Liquid Metal Embrittlement in Resistance Spot Dissimilar Welds on Advanced High Strength Steels:

Microstructure and Fracture Characteristic

Undergraduate Research Thesis

The Ohio State University

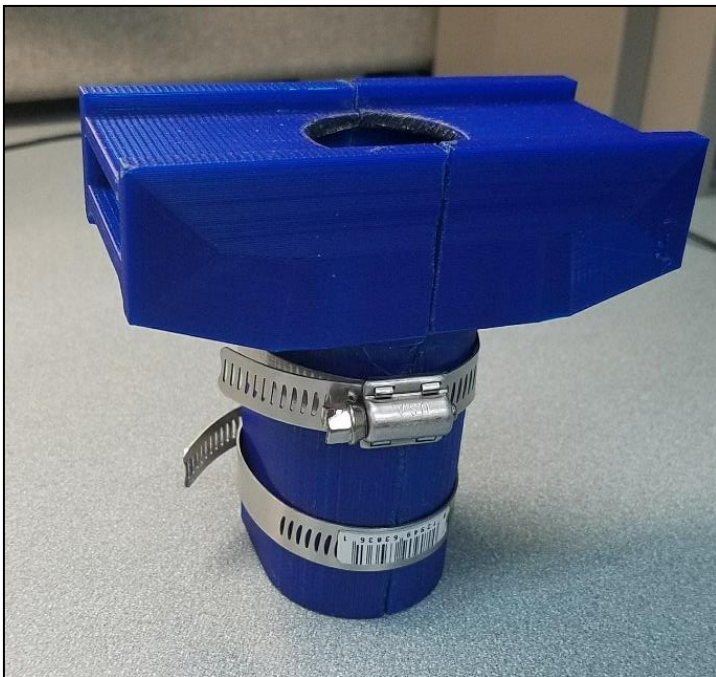
Figure 14: 3-D printed job utilized during Weld Set # 4

One weld was performed for each AHSS in dissimilar metal combination with the Zn-galvanized steel for Weld Set #4. While the fixture was able to deform the two DP steels prior to performing the weld sequence, the polymer material strength was not enough to deform the Usibor-1500 before the fixture fractured. It was noted that the fixture was required to be cut into two pieces to allow for the removal of the steel samples once the welding process was complete (Figure 14). It has been suggested that forces provided during the welding process alone are not enough to cause LME [8]. So higher forces of 900 lbs were used for this weld set to provide the necessary contact of the separated materials to be welded, providing additional stresses. Deforming the sheets was suggested by Gaul et al as a possible cause of LME cracking [18]. Additional weld parameters used were Type-E Class II electrodes, weld time of 267 msec, hold time of 300 msec, and current of 12 kA (Table 5). Higher currents were utilized from Weld Sets #1 - #3 to provide more heat input in addition to the higher stresses. After welding, the weld samples of the two DP steels were examined for surface cracking before metallographic preparation.

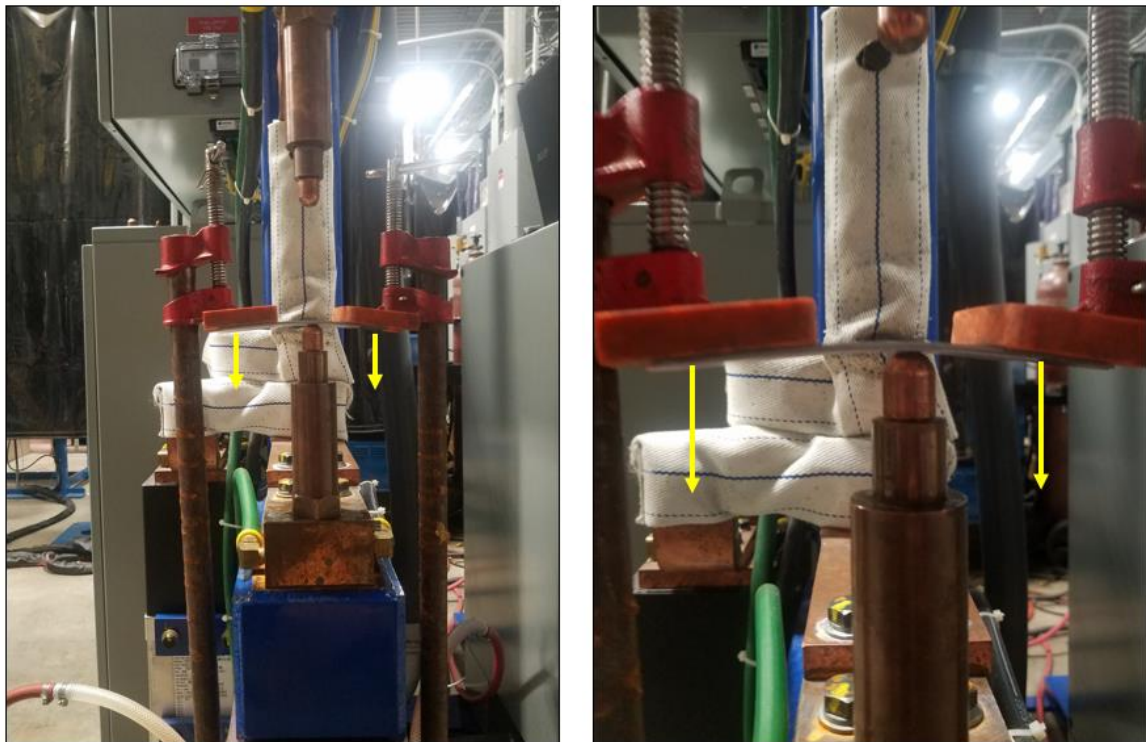
Figure 22: External clamping system utilized in Weld Sets #11 - #13.

In order to apply a large amount of external tensile stresses to the AHSS materials while being welded, a clamping system as utilized, bending the steel samples over the bottom electrode (Figure 22). Type-B domed electrodes were used for all three weld sets. Different combinations of weld force and current were used, while weld and hold times were held constant (Table 11). One weld was performed on each AHSS in dissimilar combination with the Zn-galvanized steel for each weld set. The samples were inspected for surface cracking before metallographic preparation and LOM examination.
